HEULE CASE STUDY

Precision Machining Application BSF

A Stronger and More Reliable Spotface Tool for Machining Iron

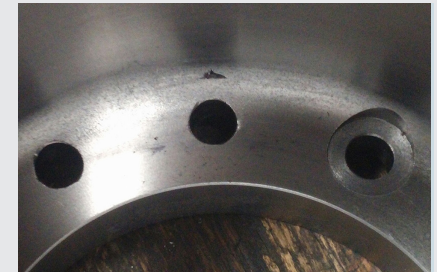
Before: Tool failure after one hole due to interruption.

A precision machining shop focused on earth moving, rail, highway engines, power generation, and construction markets was using another company's back spotfacing tool, but came to HEULE after continuous problems with tool breakage after less than 10 holes while manufacturing a cast iron engine pulley.

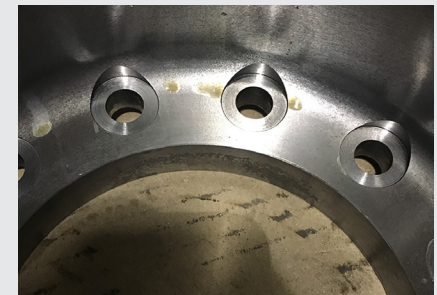
After: Spotfaces made with the HEULE BSF.

The HEULE BSF cut the initial run of 200 holes with no breakage and an excellent surface finish. The customer was "really impressed with how nice the spotfaces and sidewall looked."
